HYDROMODIFICATION SCREENING

LAKE JENNINGS MARKETPLACE

RECORD ID: PDS2014-GPA-14-005; PDS2014-REZ-14-004;
PDS2014-TM-5590; PDS2014-STP-14-019; PDS2014-MUP-15-004
Environmental Log No.: PDS2014-ER-14-14013

Wayne W. Chang, MS, PE 46548

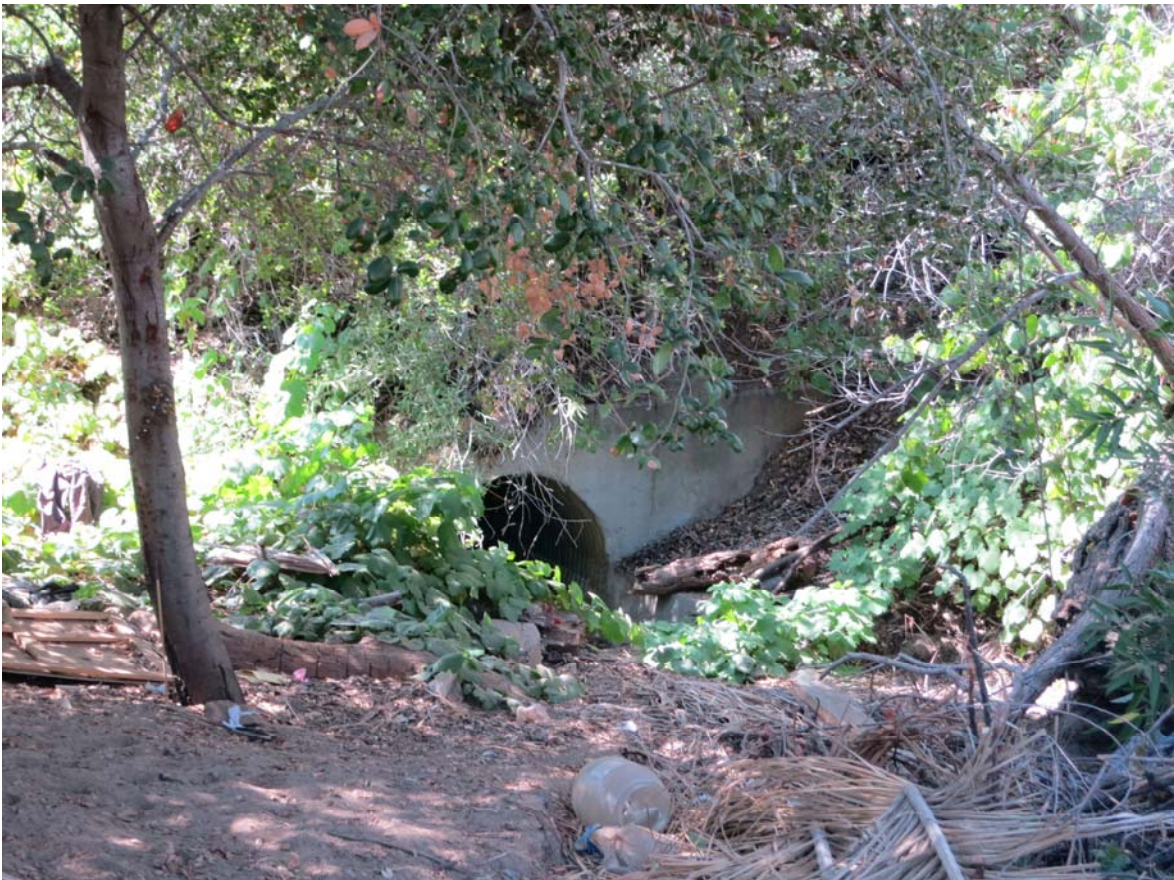
Figure 4. Existing Culvert under Ridge Hill Road at Downstream End of Reach 2

Per the first bullet item, the first permanent grade control below POC A was located. A site inspection revealed that a permanent grade control exists at the entrance of the existing culvert under Ridge Hill Road (see Figure 4). The culvert is a corrugated metal pipe with a concrete apron so it will maintain the upstream channel bed elevations. Since the culvert is under a public roadway, it is considered to be a permanent facility.

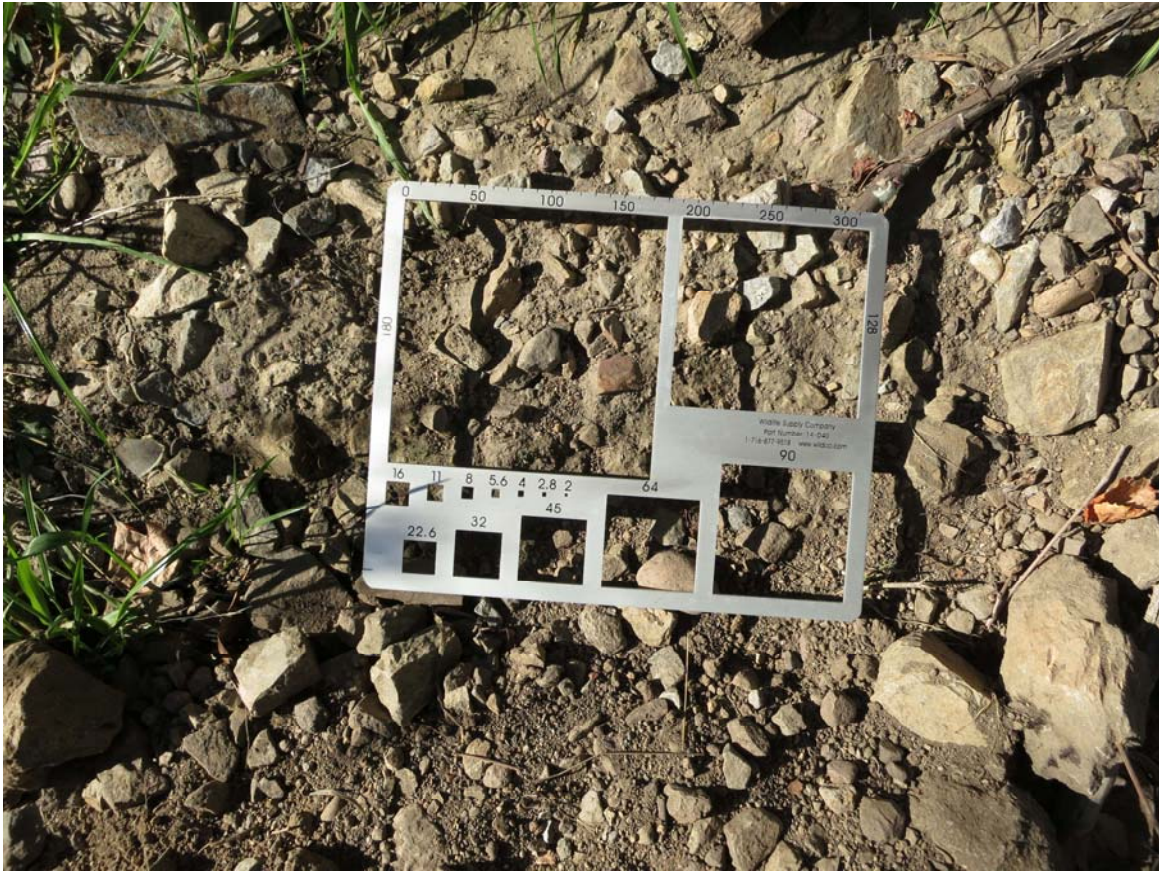
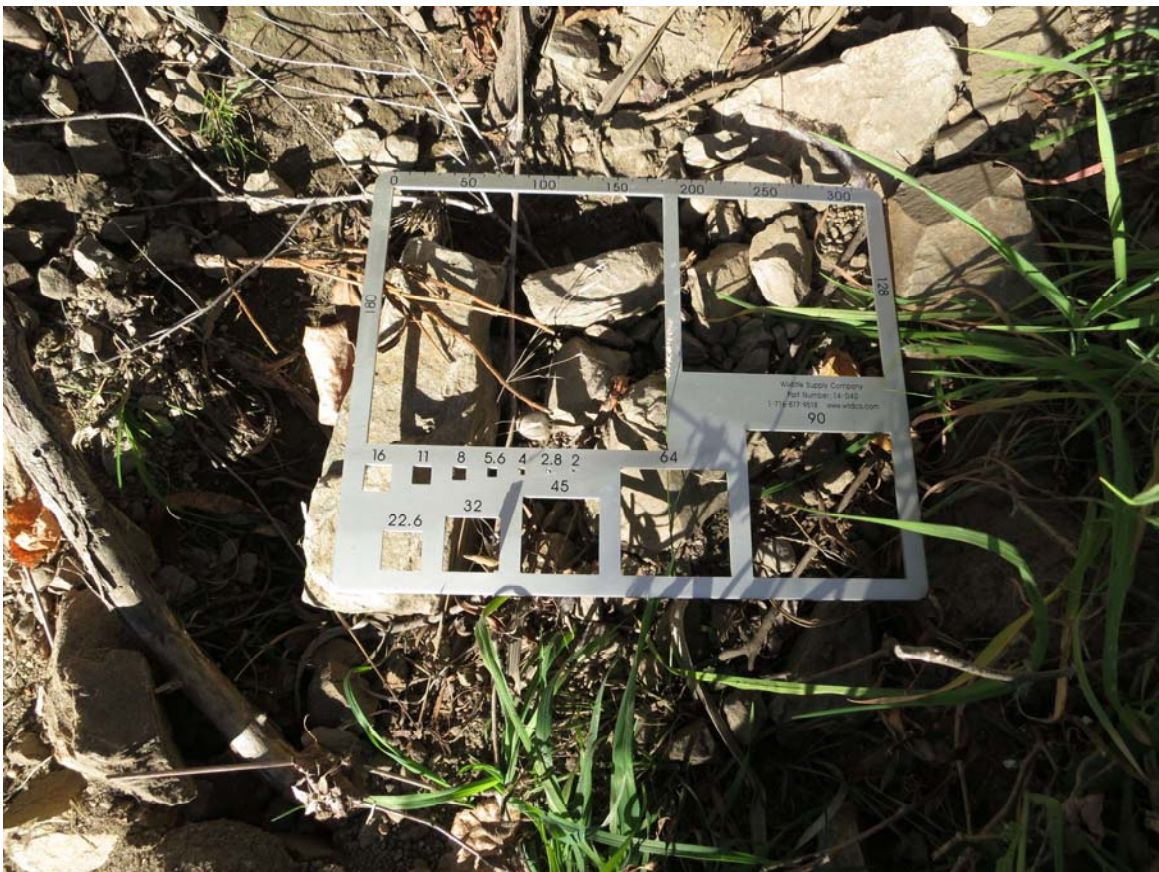
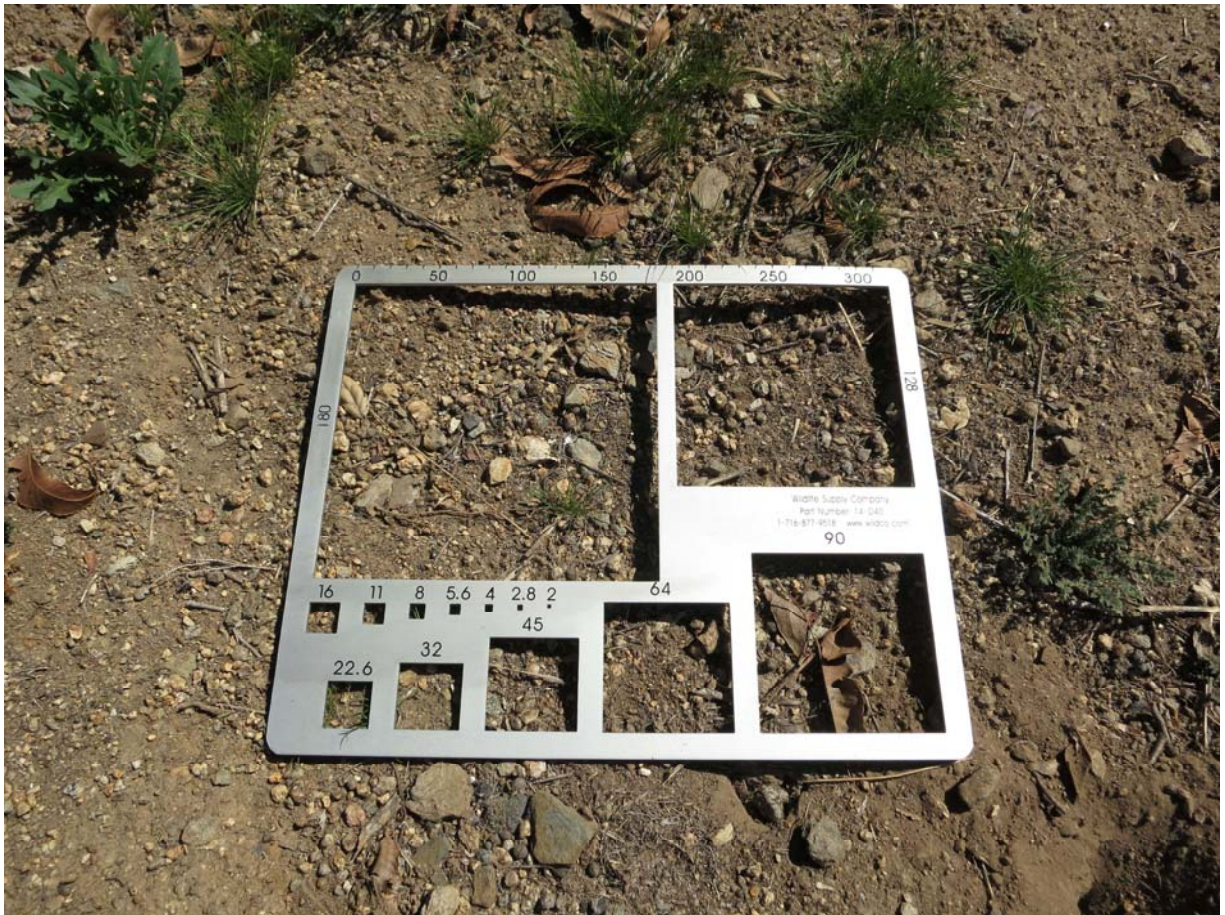
Figures 9 through 11 contain photographs of the bed material within the each of the three study reaches. A gravelometer is included in the photographs for reference. Each square on the gravelometer indicates grain size in millimeters (the squares range from 2 mm to 180 mm). Based on the photographs and site investigation, the bed material and resistance is within the transitional/intermediate bed category in all reaches. There was no evidence of a threshold bed condition. However, some bed areas contained smaller grain sizes found in a labile bed. A pebble count was performed that determined the median (d_{50}) bed material sizes for Reaches 1 through 3 varies from 16 to 32 millimeters (see Appendix B). Figure 6-4 in the County HMP indicates that a d_{50} of 16 mm or greater is within the transitional/intermediate bed category. Dr. Eric Stein from SCCWRP, who co-authored the *Hydromodification Screening Tools: Field Manual* in the *Final Hydromodification Management Plan* (HMP), indicated that it would be appropriate to analyze channels with multiple factors that impact erodibility using the transitional/intermediate bed procedure. This requires the most rigorous steps and will generate the appropriate results for the size range.

Checklist 1 determines armoring potential of the channel bed. The channel bed along each of the four study reaches is within Category B, which represents intermediate bed material of unknown resistance or unknown armoring potential due to a surface veneer such as vegetation. Figures 1 through 8 show that the entire unnamed natural channel course contains a dense cover of mature vegetation including grasses, large brush, and large trees. Figures 9 through 11 show that the

channel material contains gravel-sized particles and larger. The soil was probed and penetration was relatively difficult through the underlying layer.

Figure 9. Gravelometer within Reach 1

Figure 10. Gravelometer within Reach 2

Figure 11. Gravelometer within Reach 3
